MARYLAND HISTORICAL TRUST DETERMINATION OF ELIGIBILITY FORM

Property Name: Cricket Creek Farm		Inventory Number: HO-480
Address: 6300 Guilford Road	City: Clarksville	Zip Code: 21209
County: Howard	USGS Topographic Ma	p: Clarksville
Owner: Linda and Wilbur Speer		is the property being evaluated a district? yes
Tax Parcel Number: 89 Tax Map Number		Number: 357128
Project: Hoddinott Property	Ag	ency: Army Corps of Engineers & MDE
		Date:
s the property located within a historic district?		
If the property is within a district	District 1	inventory Number:
NR-listed districtyes Eligible distri	ctyes District N	ame:
Preparer's Recommendation: Contributing	resourceyesno No	on-contributing but eligible in another context
Preparer's Recommendation: Eligible	Considerations:A	B _ C _ D _ E _ F _ G _ None of Historic Places, 1978
Description of Property and Eligibility Determ	nination: (Use continuation sheet if	necessary and attach map and photo)
which is sited at the west end of the proprunning in a north-south direction cuts the are surrounded by paddocks, include a dybuilding/garage, two large and small wood	perty, and mature trees par rough the eastern portion of welling, a barn, a corn

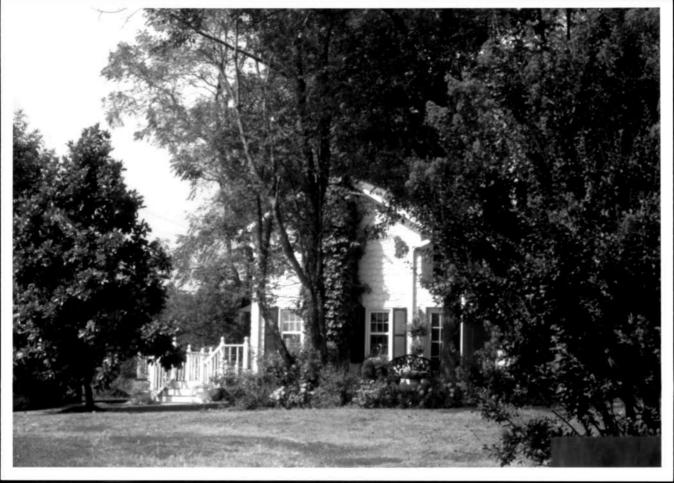
Shutters define the window openings. A single-story, shed-roof addition is appended to the north elevation. The east elevation is partially obscured by trees and the south elevation is not visible; however, aerial photographs and visual observation suggest an addition and porch also were constructed on the south elevation.

The east elevation has two six-over-six-light vinyl windows that flank the chimney on the first floor, while the west elevation has one vinyl window box at the first floor and a six-over-six-light vinyl replacement window with vinyl fanlight above on the second floor. Three six-over-six-light vinyl replacement windows are found on the second floor of the north elevation.

MD SHPO HO-480_2008-08-26-01 Photo # lof 12 Dwelling, east elevation

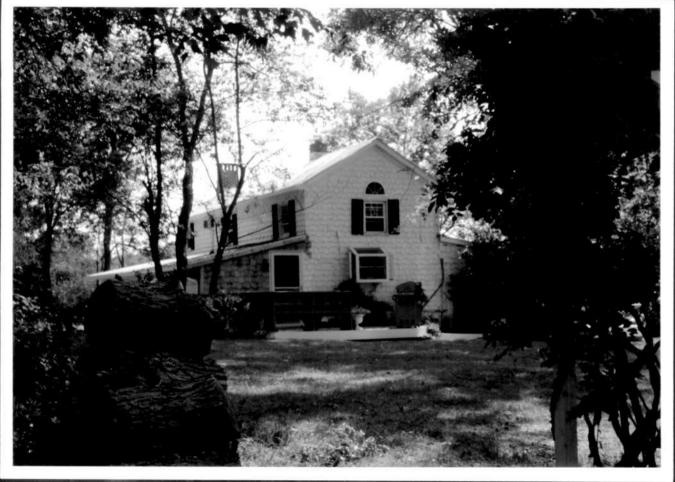
MIMP Number: HO-480
Cricket Creek Farm
Howard County, MD
Kay Dixon
08-26-2008
MD SHPO HO-480_2008-08-26_02
Photo # Z of 12
Dwelling, West elevation

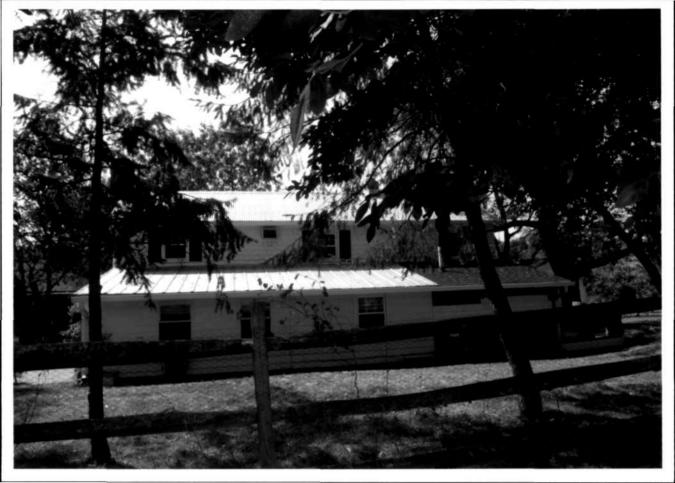
MIHP Number: HO-480 Cricket Creek Farm Howard County, MD Kay Dixon 08-76-2008 MD SHPO HO-480_2008-08-76_03 Photo # 3 of 12

The single-story addition on the north elevation terminates in a shed roof sheathed in metal panels and asphalt shingles. Cladding materials are cedar shingles on the east and west elevations and wood and what appears to be vinyl siding on the north elevation. A double-leaf sliding glass door is located on the east elevation and a door opening with storm door is found on the west elevation.

Owelling, north elevation

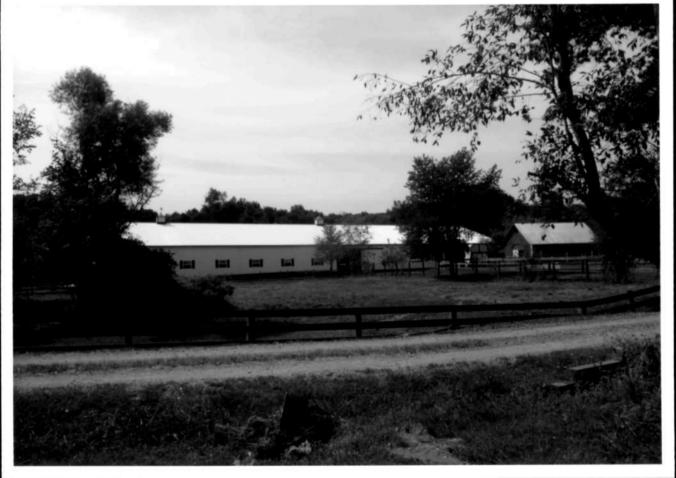
MD SHPU HO-480_2008-08-26-04 Photo # 40f 12

A late-twentieth-century prefabricated metal building is located southeast of the dwelling. The building occupies a rectangular footprint and faces north. The building terminates in a side-gable roof sheathed in prefabricated metal; three metal ventilators pierce the roof ridge. Two sliding tract doors are centered on each the north and east elevations. Ten window openings with eight-over-eight-light, double-hung sash characterize the north elevation; the windows appear to be vinyl. Shutters flank the windows. A fanlight window is centered above the door on the east elevation. Aerial images of the building suggest windows also are located on the south elevation. The west elevation is not visible.

The nineteenth or twentieth-century wood-frame corn crib, which is located near the northwest corner of the large metal building, terminates in a front-gable roof sheathed in metal panels and is clad in vertical wood siding. The east and west elevations each contain one door opening. Visual observation suggests the door opening centered on the east elevation has been modified to accommodate a smaller door. The east elevation also contains a window opening in the gable end; the sash is no longer extant. A single-story wood-frame addition appears to have been constructed on the north elevation. A door is located on the addition's west elevation. The south elevation is not visible.

Large metal building and cornerib, north elevation

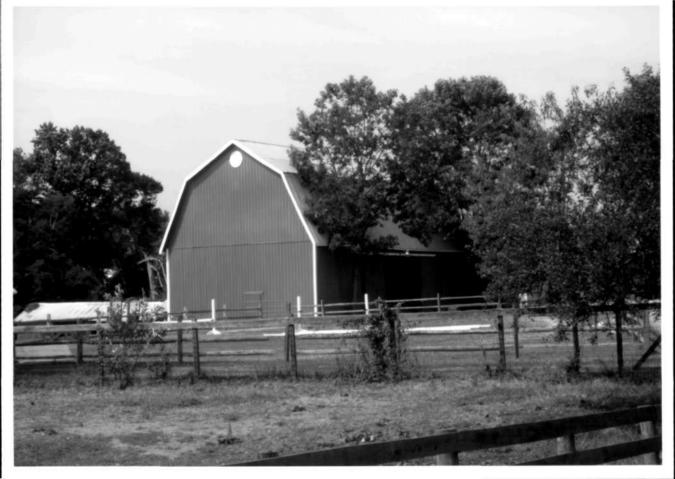
A twentieth-century barn is located north of the large metal building. The barn occupies a rectangular footprint and terminates in a gambrel roof sheathed in metal panels. Cladding materials could not be determined. Door openings characterize the north and south elevations, with the opening on the north elevation consisting of a sliding-tract door. A circular vent is found on the east elevation's gable end. Two additions were constructed. A single-story, shed-roof, wood-frame addition was constructed on the west elevation. A single-story, gable-roof, wood-frame protrusion extends from the southwest corner of the south elevation; aerial photographs suggest the protrusion is an addition.

MIHP Number: Ho-480
Cricket Creek Farm
Howard County, MD
Kay Dixon
08-26-2008
MD SHPO HD-480_2008-08-26_05
Photo # 5 of 12
Barn, north and east elevations

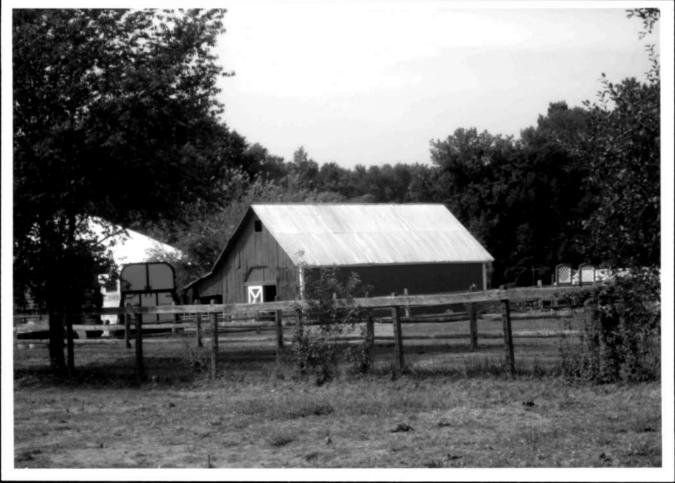
Photo # 6 of 12

Corn crib, north and east elevations

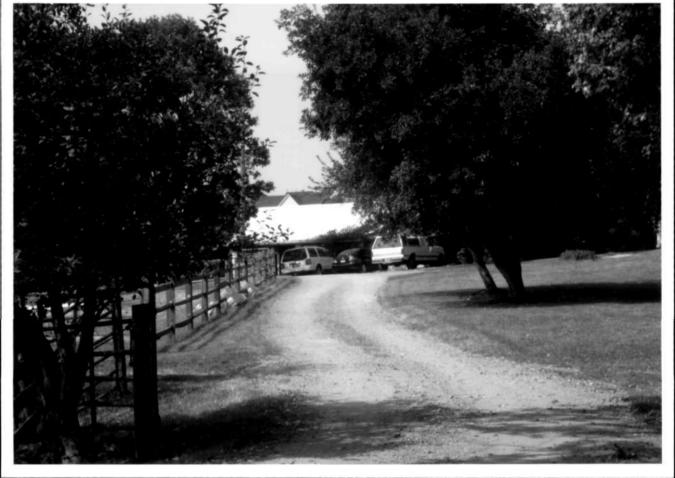
A twentieth-century concrete-block equipment storage building/garage is located south of the dwelling. The building, which occupies a rectangular footprint, terminates in a side-gable roof sheathed in prefabricated metal panels. The east (front) elevation is partially obscured by trees; the number of bays could not be determined. Two openings consisting of one one-over-one-light, double-hung window and one opening, the sash of which is no longer extant, characterize the west elevation. Aerial photographs suggest a single-story addition was appended to the south elevation. The portion of the addition that extends from the southwest corner of the west elevation of the principal block is visible. The addition terminates in a shed roof. A large opening defines the addition's north elevation. The west elevation of the addition is blind, and the south elevation is not visible.

MIHP Number: HO-480 Cricket Creek Farm Howard County, MD Kay Dixon 08-76-2008 MD SHPO HO-480_2008-08-26-07 Photo # 7 of 12 Equipment storage building/garage, east elevation

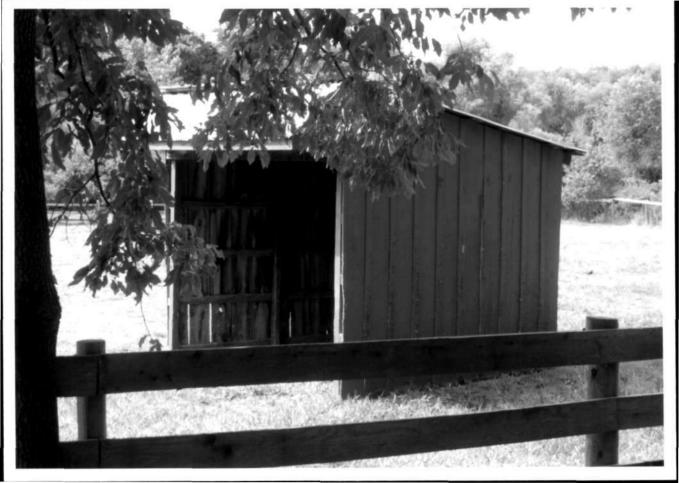
A twentieth-century, wood-frame, board-and-batten animal shelter sits perpendicular to the driveway and is located west of the creek. The building terminates in a shed roof sheathed in prefabricated metal panels.

MIHP Number: HO-480 Cricket Creek Farm Howard County, MD Kay Dixon 08-56-5008 MD SHPO HO-480_ 2008-08-26-08 Photo # 8 of 12 Small animal shelter, northeast corner

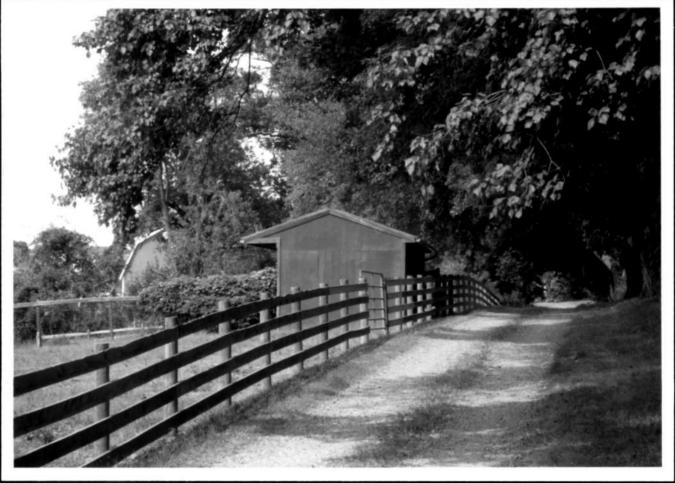
A twentieth-century, wood-frame animal shelter is located west of the small animal shelter and sits parallel to the driveway. The building terminates in a gabie roof sheathed in corrugated metal and is clad in vertical wood planks.

MIHP Number: HO-480
Cricket Creek Farm
Howard Connty, MD
Kay Dixon
08-26-2008
MD SHPO HO-480_2008-08-26_09
Photo # 9 of 12
Large animal shelter, east elevation

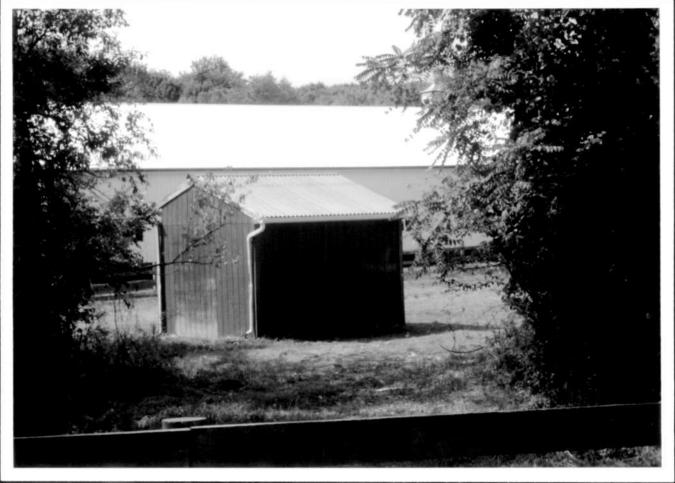
A small, twentieth-century, wood-frame building is found north of the large metal building. The building terminates in a side-gable roof sheathed in corrugated metal and is clad in vertical wood planks. The north and east elevations are blind; the south and west elevations are not visible.

MIHP Number: 40-480 Cricket Creek Farm Howard County, MO Kay Dixon 08-26-5008 MD SHPO HO-480_2008-08-26-10 Photo # 10 of 12 Small wood-frame building, north and east elevations

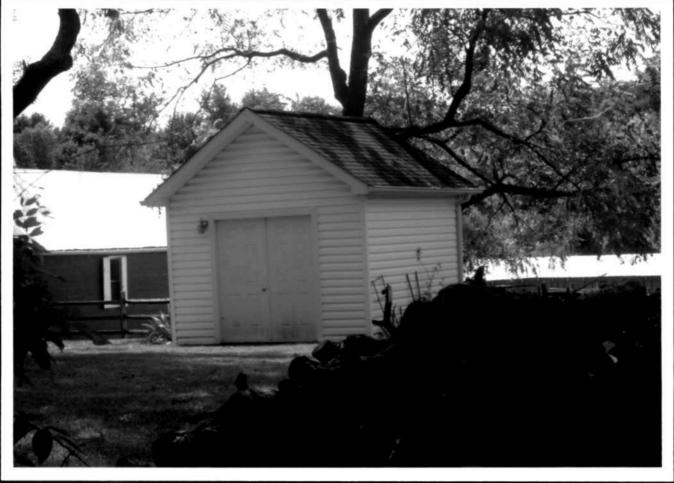
A late-twentieth-century, wood-frame building is located southwest of the dwelling. The building terminates in a front-gable roof sheathed in asphalt shingles. Cladding materials are horizontal wood siding. Openings consist of a double-leaf door on the north elevation and two window openings flanked by shutters on the east elevation. The type of windows could not be determined. The west elevation is blind and the south elevation is not visible.

MIHP Number: HO-480
Cricket Creek Farm
Howard County, MD
Kay Dixon
08-26-2008
MD SHPD HO-480-2008-08-26-11
Photo#11 of 12
Large wood-frame building

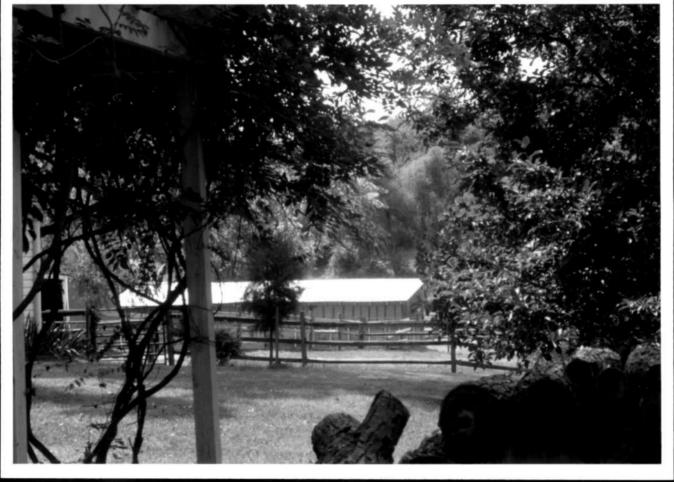
A twentieth-century, wood-frame animal shelter is located south of the dwelling and terminates in a shed roof sheathed in metal. Cladding materials appear to be board and batten. The north elevation is partially obstructed and the east, south, and west elevations are not visible.

MIHP Number: 40-480 Cricket Creek Farm Howard County, MD Kay Dixon 8005-92-80 MD SHPO HO-480_2008-08-26-12 Photo # 12 of 12 Animal shelter, north elevation

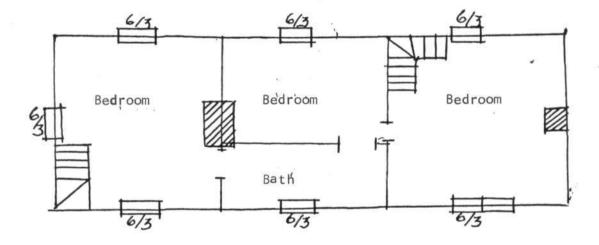
Figure 1 H0-480 Cricket Creek Farm First Floor Plan

Rectangular entrances are located on the north and south elevations of the house. See Figure 1, first floor plan. Fenestration for the house is vertically aligned and proportionally saled, featuring first floor double hung windows with six-over-six lights in the original log house and six-over-three light second floor windows. The later nineteenth century addition features two-over-two light first floor windows and similar six-over-three light second floor windows.

The original log house held two first floor rooms divided by a wide brick chimney, with two rooms above and a small, narrow staircase ascending to the rooms above in the southwest corner of the present kitchen. A batten wood door serves as an entrance to the staircase. A small one story high kitchen pantry is located along the kitchen's north wall with a six-over-six light window in its west wall.
